Precision 20/20 Full Reserve Study for Creekside Homeowners Association Tucson, Arizona February 6, 2013

Long-term thinking. Everyday commitment.

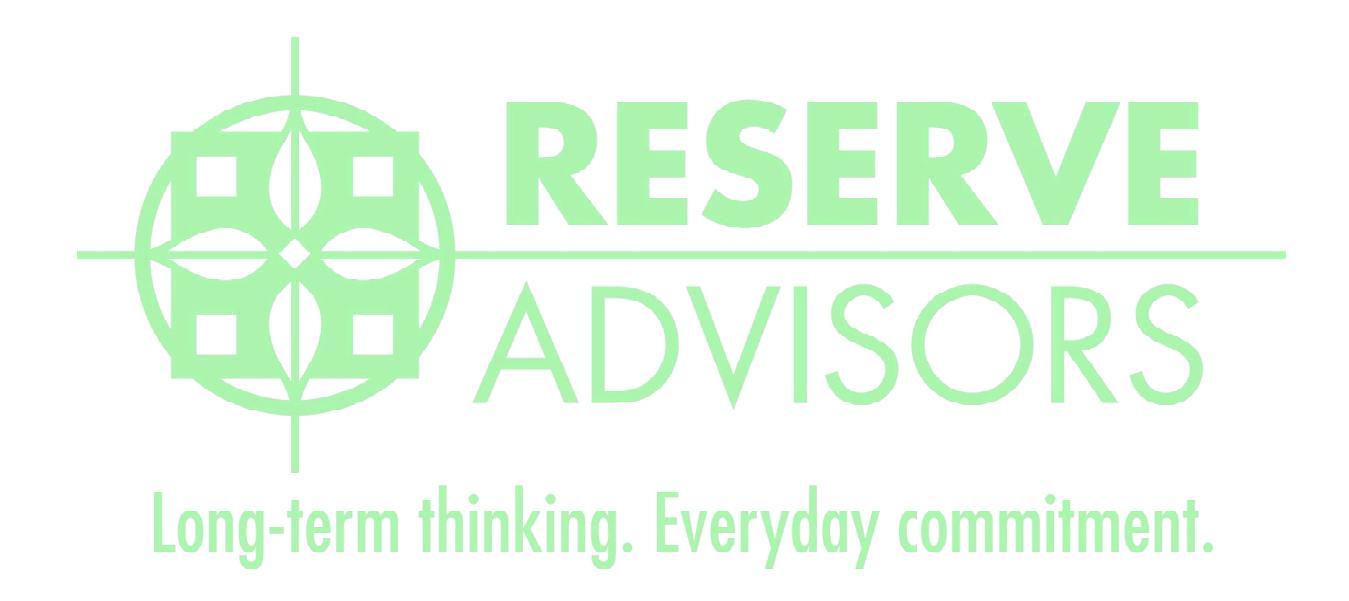
This Report contains intellectual property developed by Reserve Advisors, Inc. specific to this engagement and can not be reproduced or distributed to those who conduct reserve studies without the written consent of Reserve Advisors, Inc. See the Professional Service Conditions of the Proposal and this Report for details concerning the use of this Report.

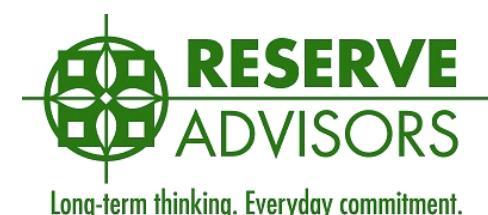
Reserve Advisors, Inc. 735 N. Water Street, Suite 175 Milwaukee, WI 53202

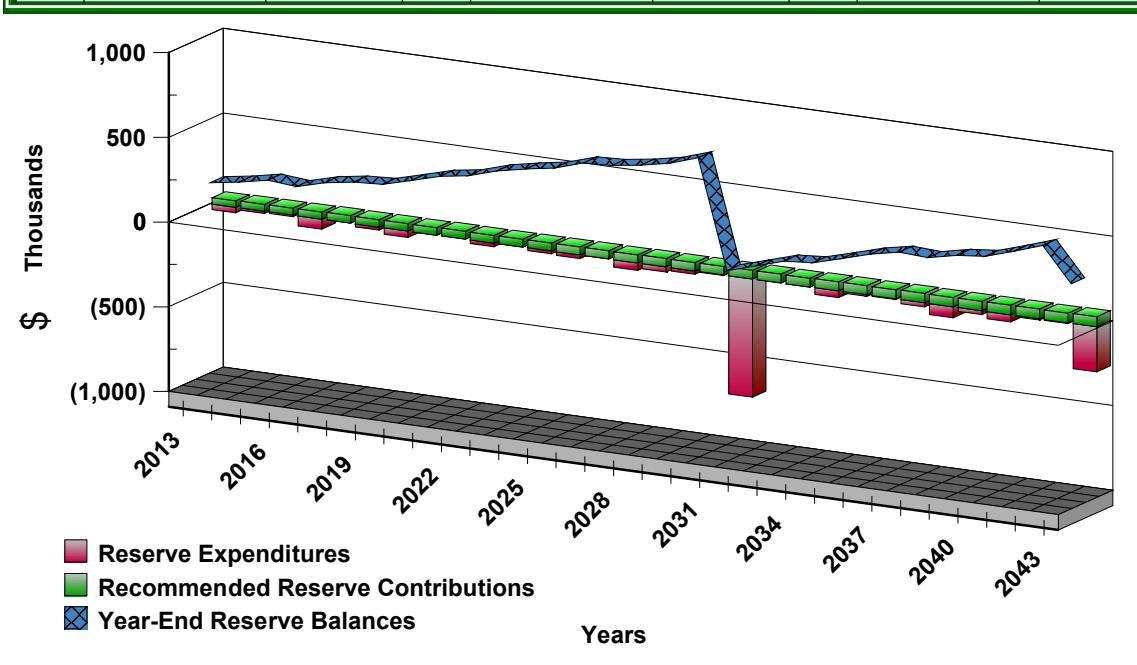
Respectfully submitted on April 2, 2013 by RESERVE ADVISORS, INC.

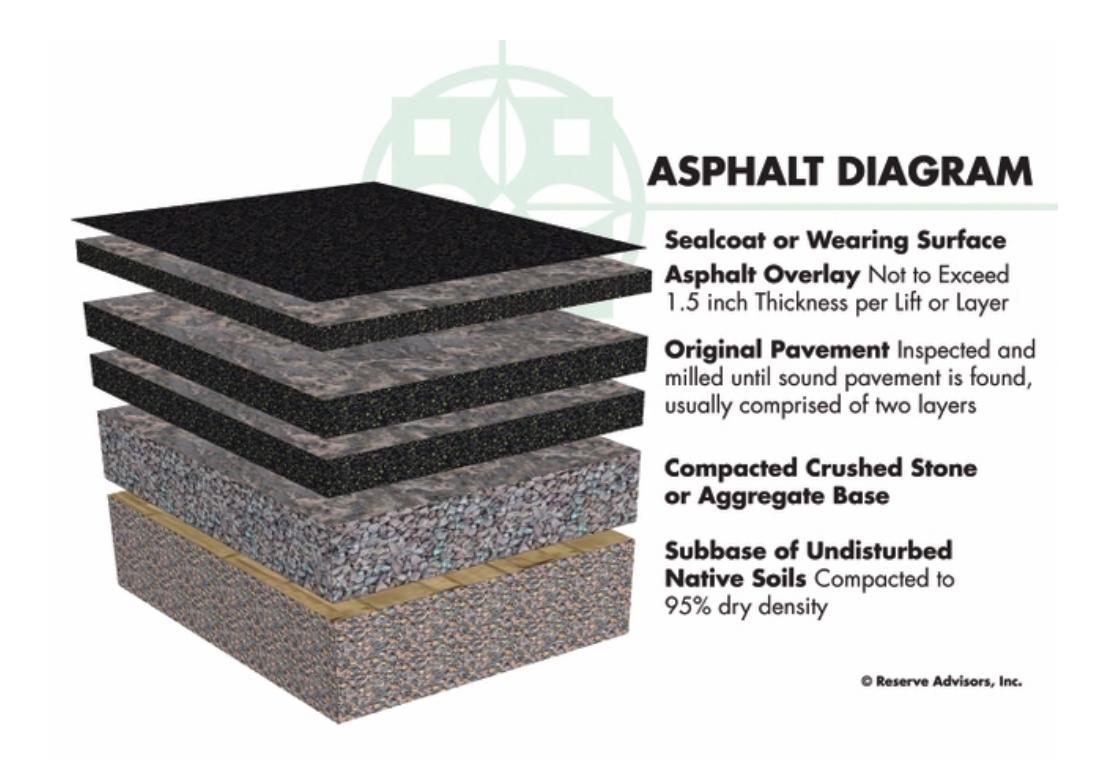
The manner of repaving is either a *mill and overlay* or *total replacement*. A mill and overlay is a method of repaving where cracked, worn and failed pavement is mechanically removed or milled until sound pavement is found. A new layer of asphalt is overlaid atop the remaining base course of pavement. Total replacement includes the removal of all existing asphalt down to the base course of aggregate and native soil followed by the application of two or more new lifts of asphalt. We recommend mill and overlayment on asphalt pavement that exhibits normal deterioration and wear. We recommend total replacement of asphalt pavement that that exhibits severe deterioration, inadequate drainage, pavement that has been overlaid multiple

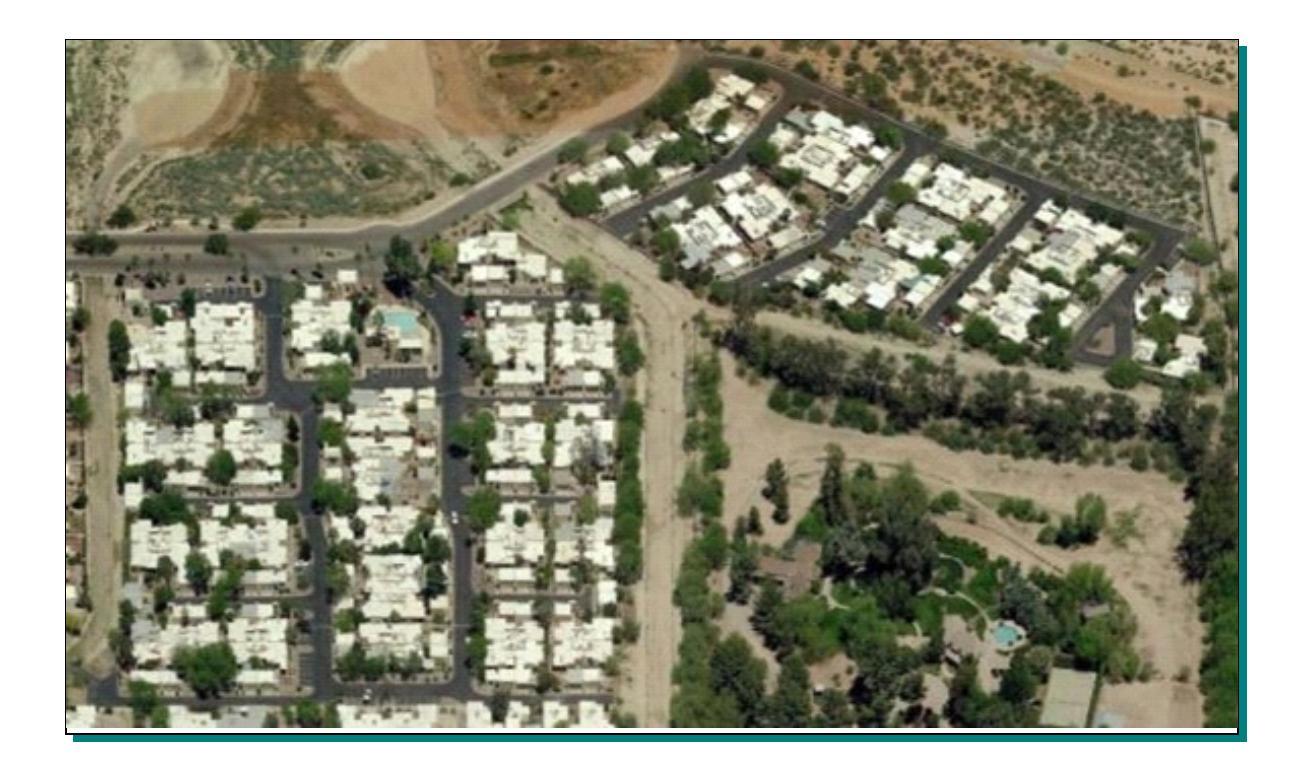
The next pages contain the photographs related to Section 4 - Condition Assessment

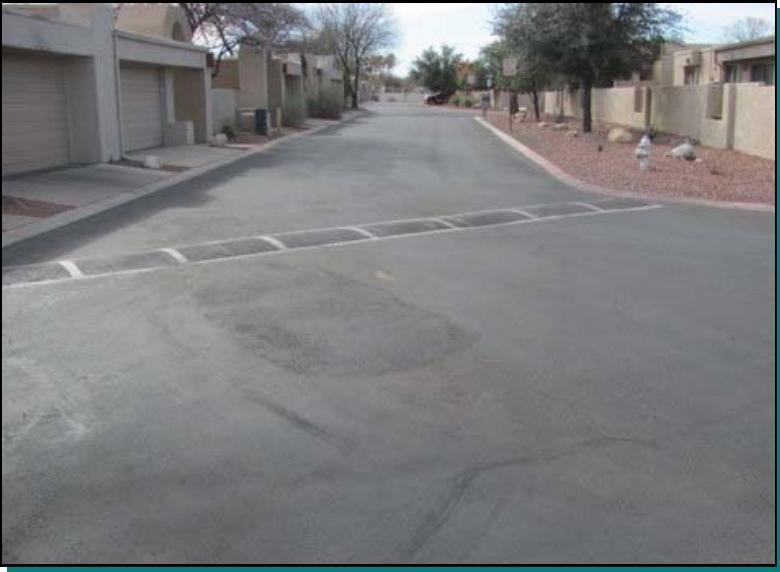
Asphalt pavement overview

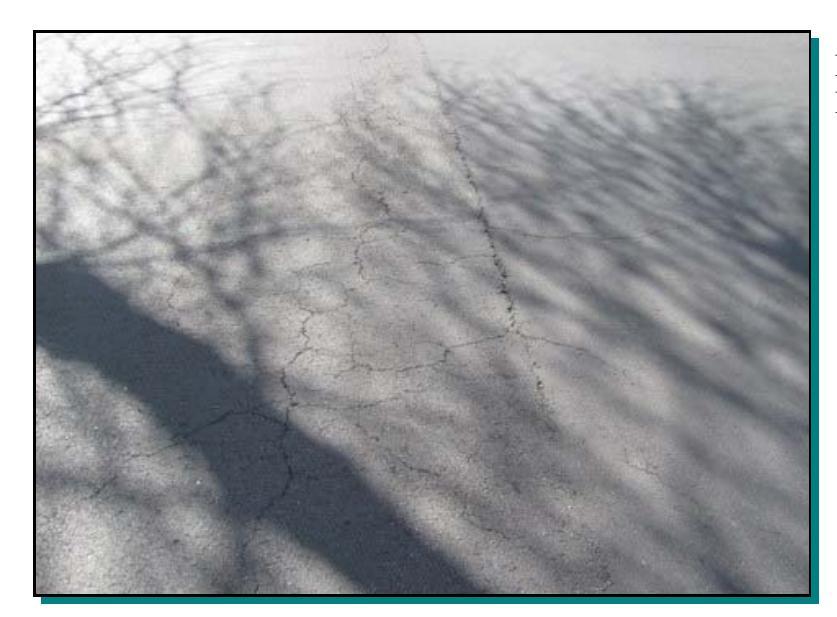
Fatigue cracks at East Dianthus Place

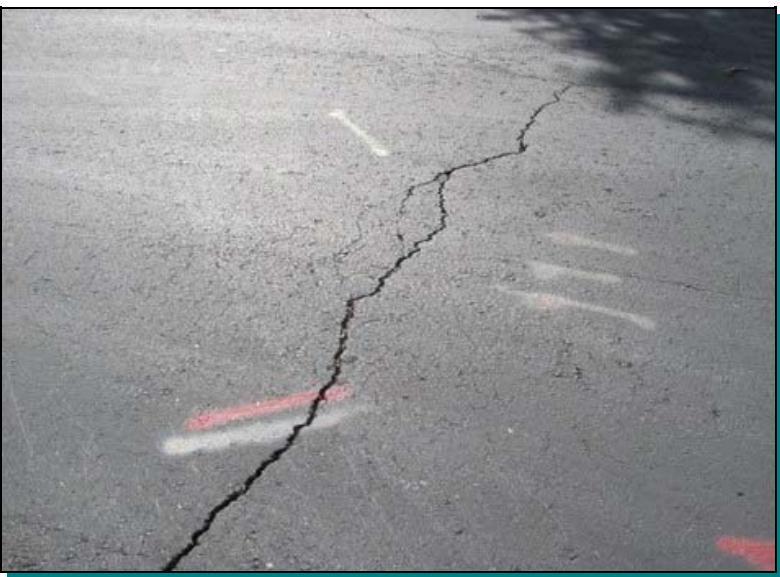
Page 5.3 - Photographs

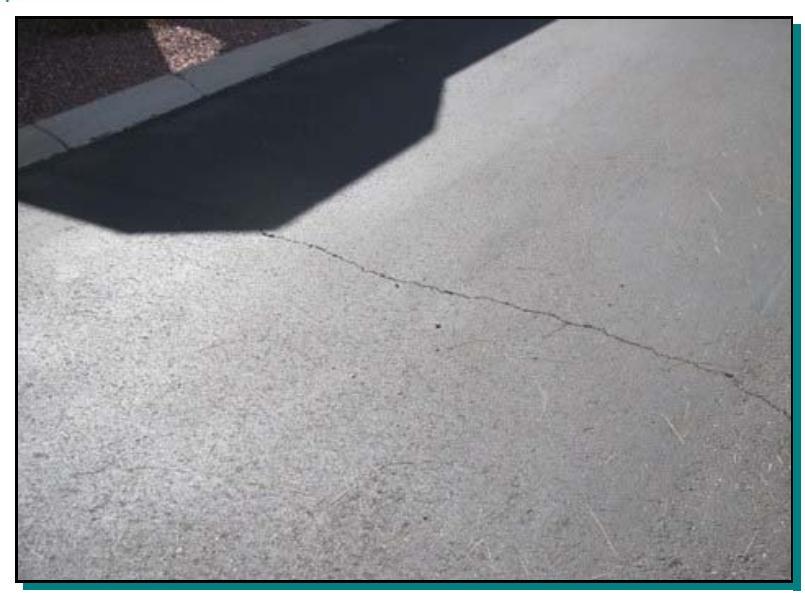
Transverse crack at Brookhaven Lane

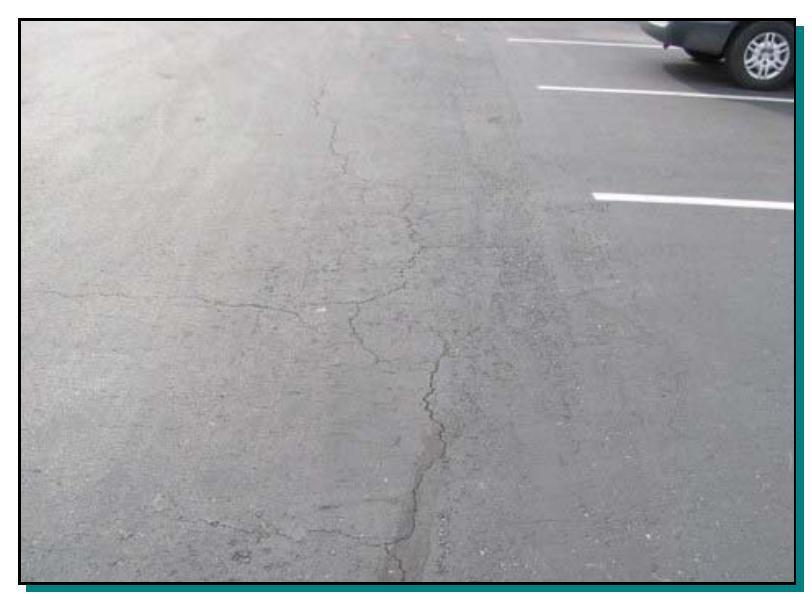
Fatigue cracks at Catalina Avenue

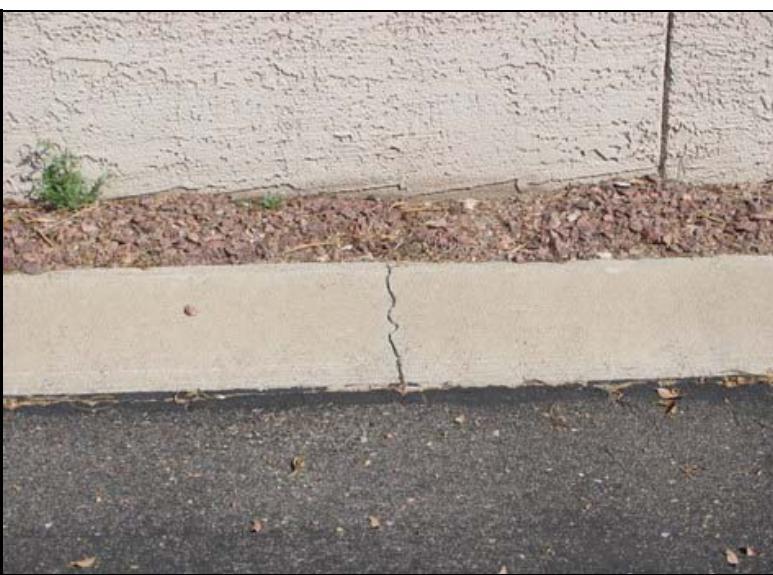
Page 5.4 - Photographs

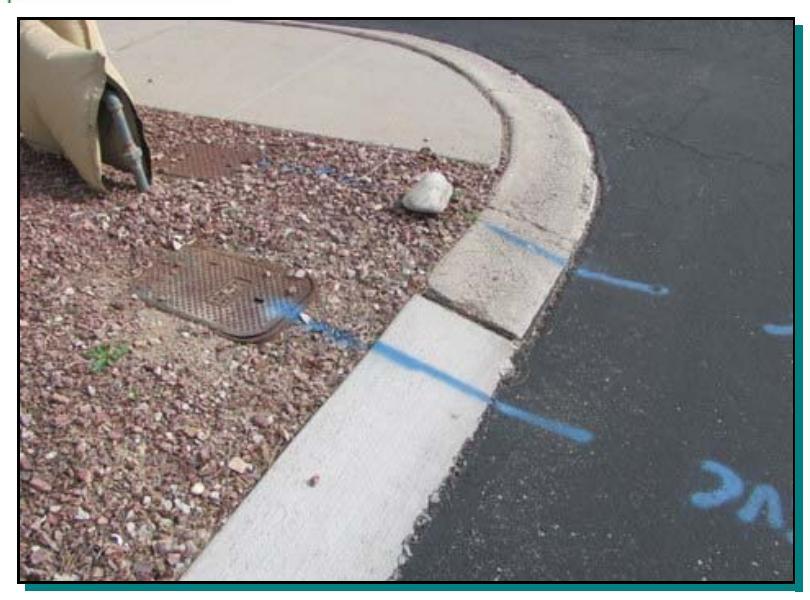
Previously replaced and original concrete gutters

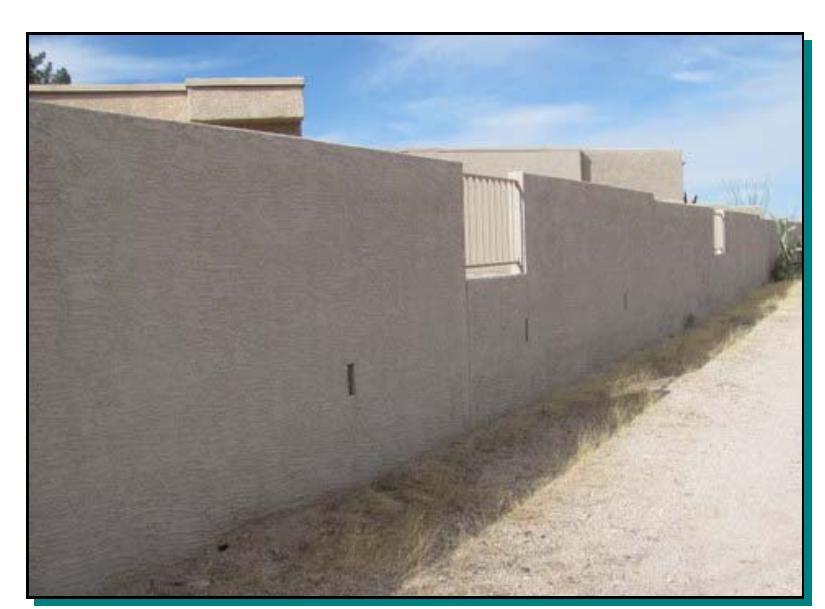
Perimeter wall overview

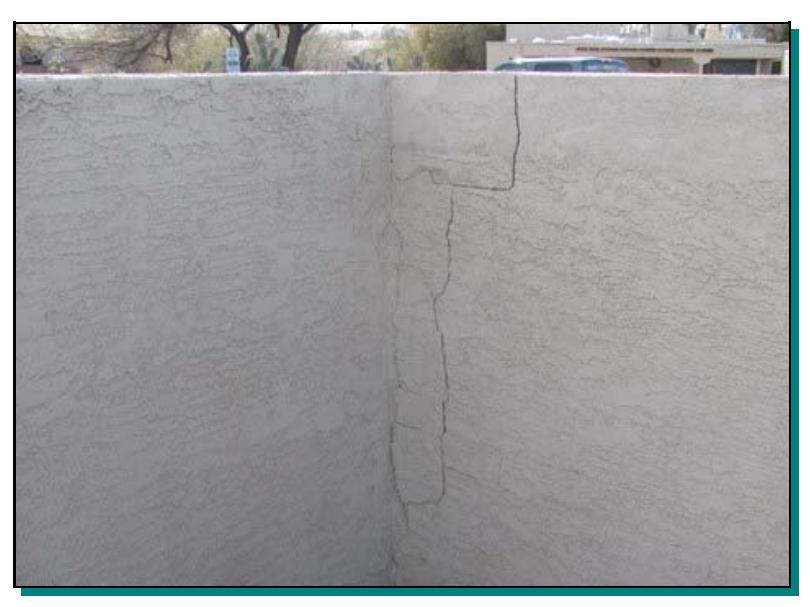
Cracks in perimeter wall corner

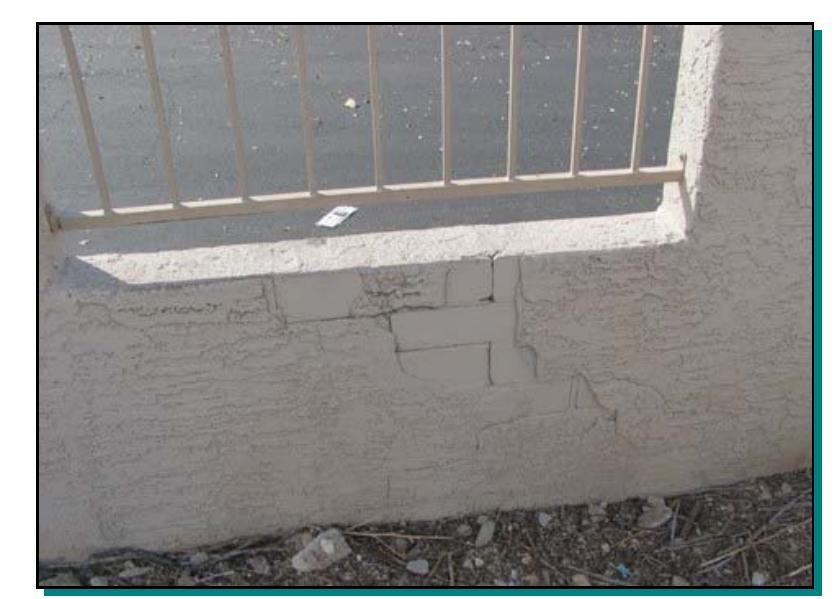
Step cracks and stucco deterioration

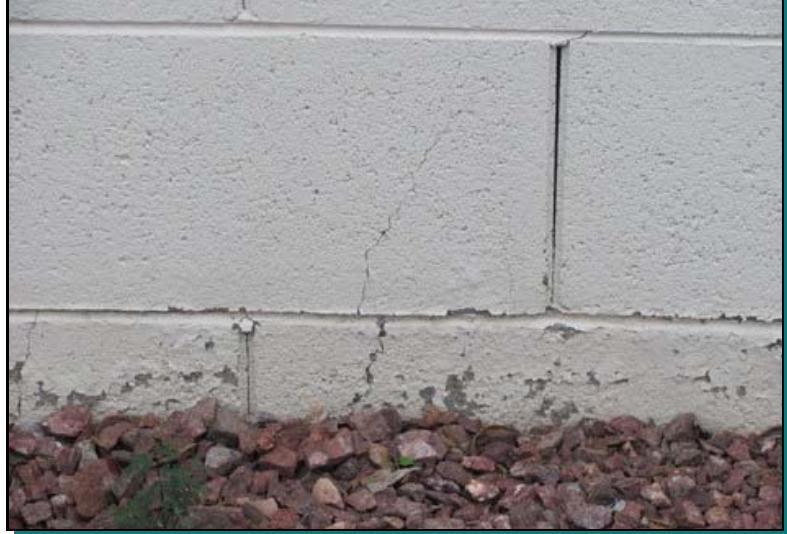
Page 5.6 - Photographs

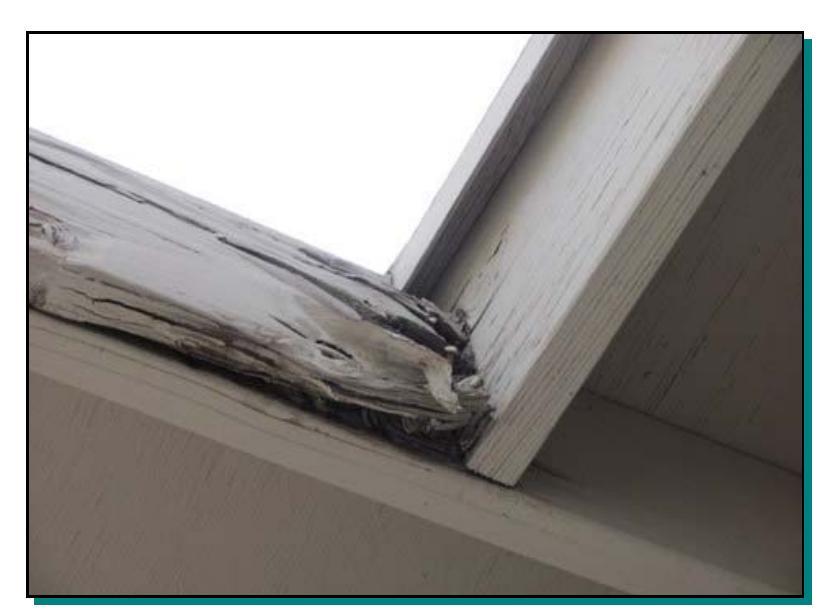
Deteriorated wood frame member at Ramada

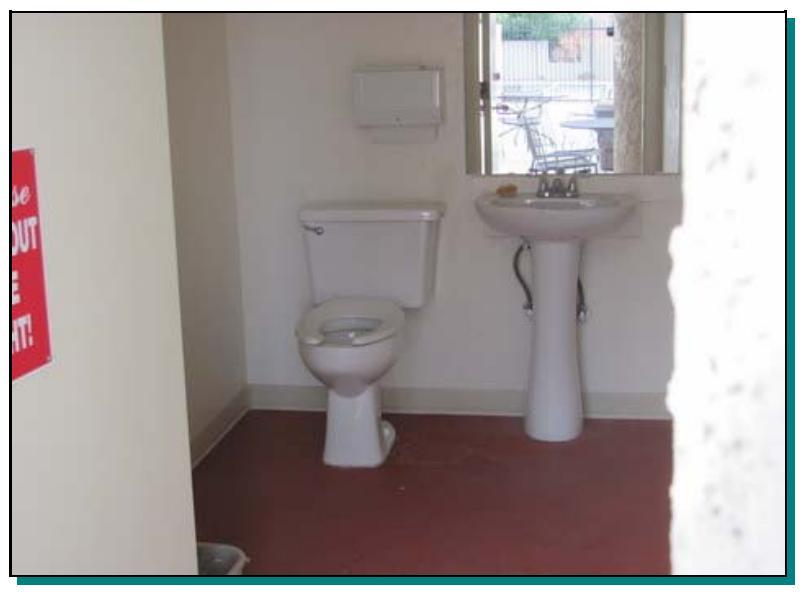
Replace through operating budget

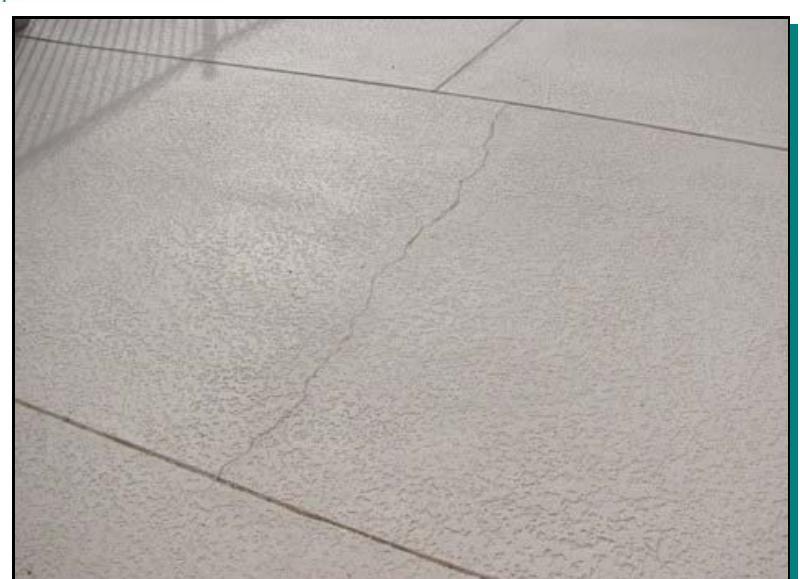
Concrete deck crack, note recent coating application

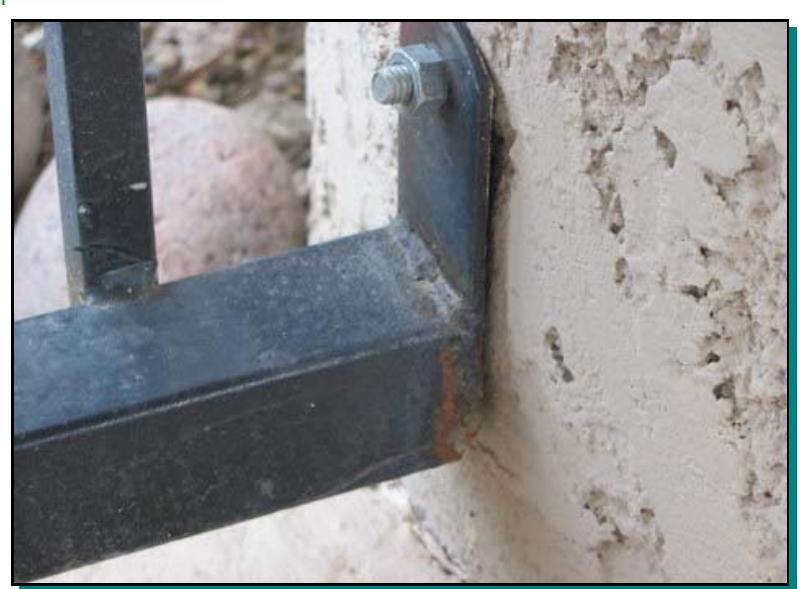
Rust at fence fastener

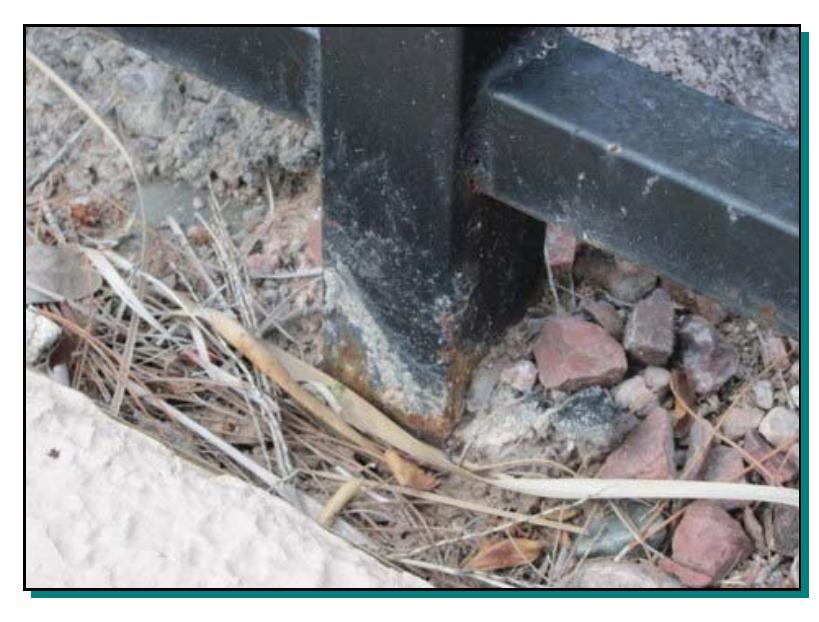
Rust at base of metal fence post

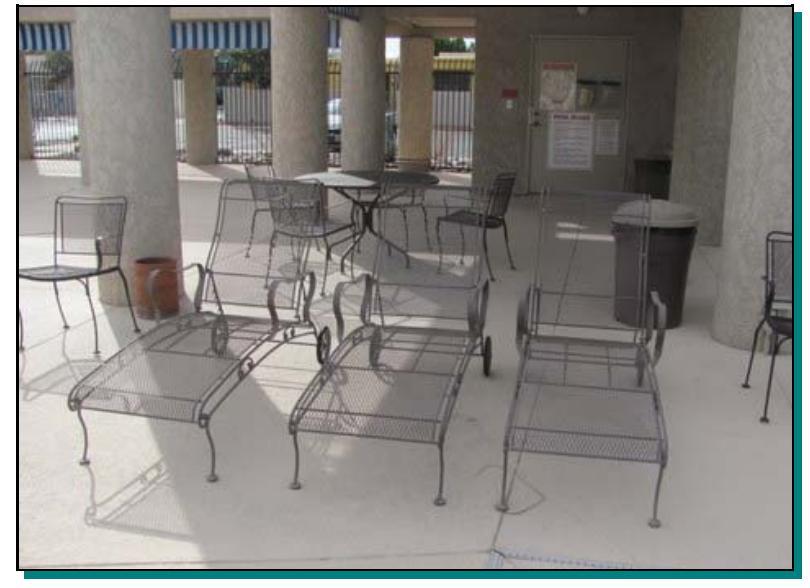
Page 5.10 - Photographs

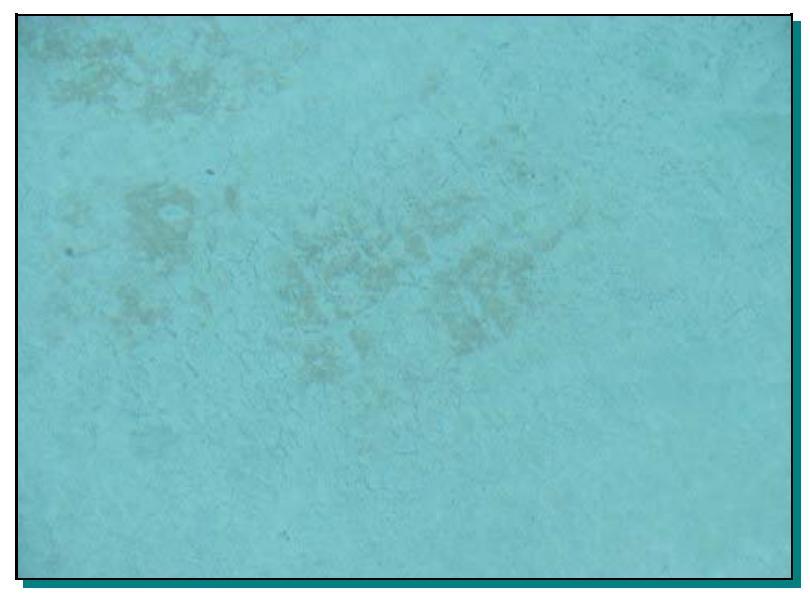
Mechanical equipment

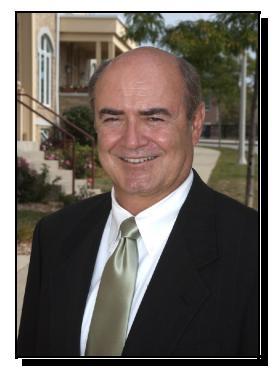
Mr. Poehlmann served on the national Board of Trustees of Community Associations Institute. Community Associations Institute (CAI) is a national, nonprofit 501(c)(6) trade association created in 1973 to provide education and resources to America's 305,000 residential condominium, cooperative and homeowner associations and related professionals and service providers. The Institute is dedicated to fostering vibrant, responsive, competent community associations that promote harmony, community, and responsible leadership.
